Problem:

Leaking door lite frame.

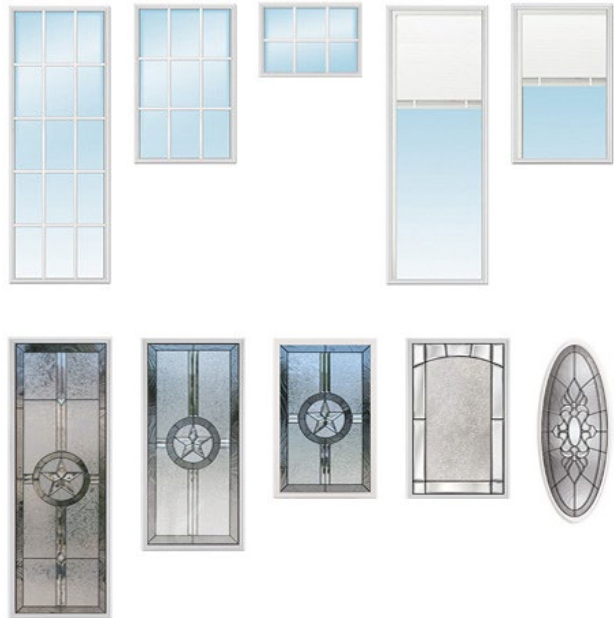
Often caused by lack of overhang and direct sunlight, or chemicals used on glass during construction.

Order replacement door lite frame:
www.finerdoors.com/parts.html

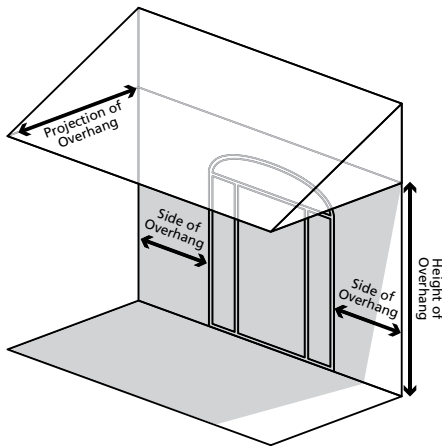
RECOMMENDED OVERHANG

The "Projection of Overhang" must measure a minimum of 1/2 the height of the entryway. The "Side of Overhang" must measure a minimum of three feet from the outside edge of the door unit. The overhang must provide protection of the door unit from direct exposure to the elements.
